SURPLUS VEHICLE FOR SALE BY SEALED BID

1991 Ford F-700 Bucket Truck

Inspection Report

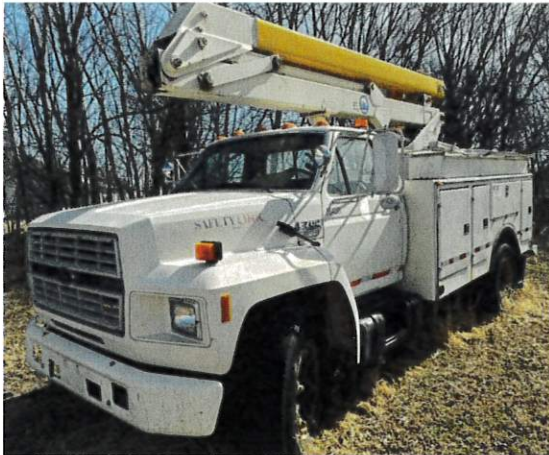
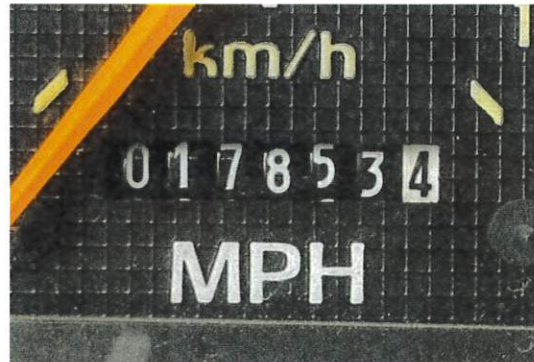
- Hydraulic Brakes
- Boom – Holan 83-A-36 [Mfg. Date 12/09/1975]
- Fuel: Gasoline
- Cylinder: 6
- GVWR: 24,500
- Odometer: 17,853
- Hours: 9166
- Weight: 14 Ton
- This unit does not have any outriggers.
- Some repairs that need to be fixed.
- Last Inspection report was completed on 08/04/2021.
- Vehicle is sold "As Is/Where Is" with no warranty. City of Shenandoah makes no warranty of any kind nor shall City of Shenandoah be held responsible for any direct or consequential damages or damages of any kind arising out of the Buyer's use of the equipment.
- Minimum Bid of \$1,000.00. All "Bids" are legally binding and you will be held accountable/liable for your winning bid.
- Full Payment will be due by 3:00 P.M. CST on the following date of Council approval on April 28, 2026. Title and Bill of sale will be arranged upon payment and removal of vehicle.
